RV Inspection

1 Jan 2024 / Joshua Flowers, Trek Tech
Mobile RV Services

Flagged items	16
Inspection Type	Buyer: Pre-Purchase Inspection
Inspection Location	Charlotte, NC, USA (35.2270869, -80.8431267)
Conducted On	01.01.2024 09:00 EST
Prepared By	Joshua Flowers, Trek Tech Mobile RV Services
RV Year, Make, Model	2010 Triple E RV, Regency GT29DBS

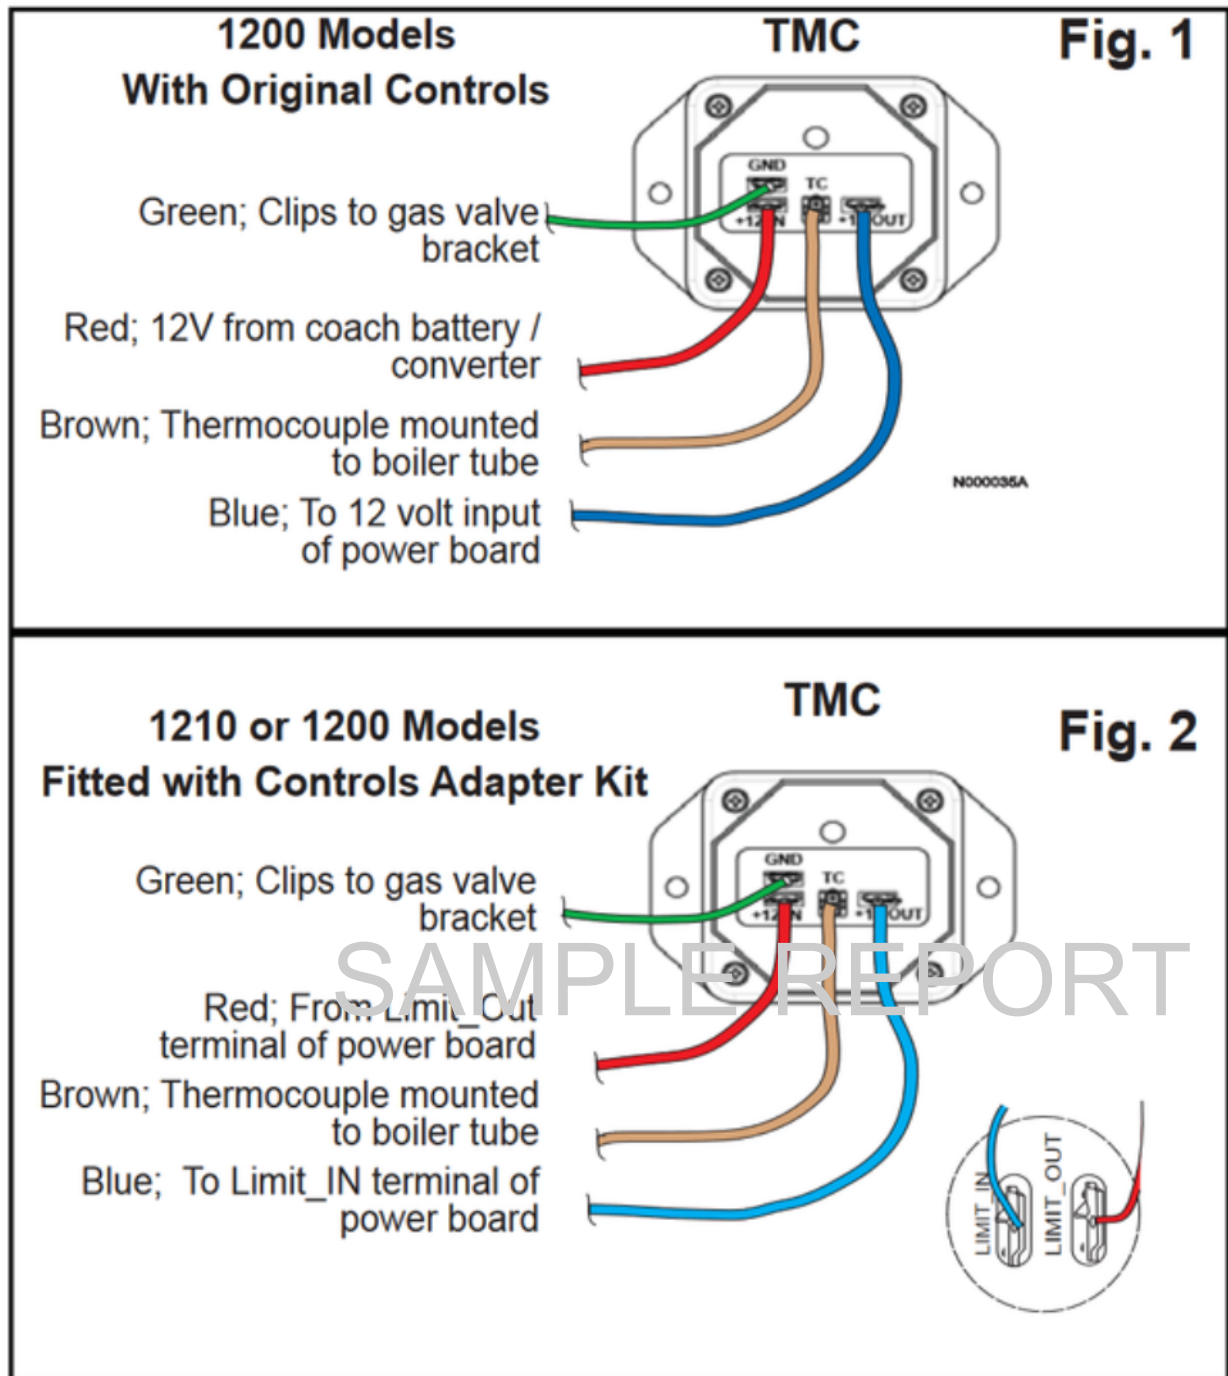
Norcold Models 1200, 1201, 1210, or 1211 refrigerators with serial numbers between 315525 and 13088811, having a cooling unit with a serial number between 700000 and 13085759 are recalled. (The affected refrigerators were manufactured on or before 10/7/2010)
